**Flood Control Project Maintenance
Levee Inspections**

Maintenance Issue Types Only, Levee Inspection Report By Mile - Spring 2019

Reclamation District No. 2060 Hastings

Waterway	Bank	Unit Miles	Inspection Start/End	Inspector
Unit No. 01 Lindsey Slough	Left	6.97	04/09/2019 04/09/2019	David Julian

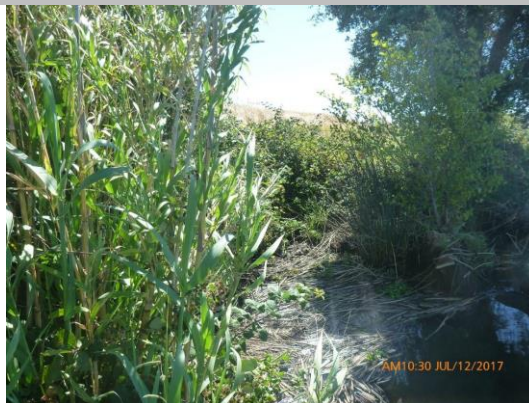
Photo 1 of 6 : SP_2019_RD2060_241_5_20190311_00001.jpg

LM Start	0.40	Rating **	M	Issue No.	5
LM End	0.40	Issue Type +	Ma	Location *	WS
Category	Supplemental			GPS Latitude/Longitude	
				Start	End
Item	2017 Storm Damage			38.247894 °	38.247911 °
				-121.703492 °	-121.703539 °
DWR ID	DWR_RD2060_01_f _ 2017_5				
Comment Code					
Inspector Comment					
Levee Evaluation Comments					
Description:Erosion commences approximately 3/4 of the way down the slope, near the water line towards the waterside toe.					
Site ID No:358					
Site Designation:LMA-185					
Repair Type: Erosion					
Rating:Area of Concern					
Field Date:7/12/2017					
Notes: Small erosion into bank.

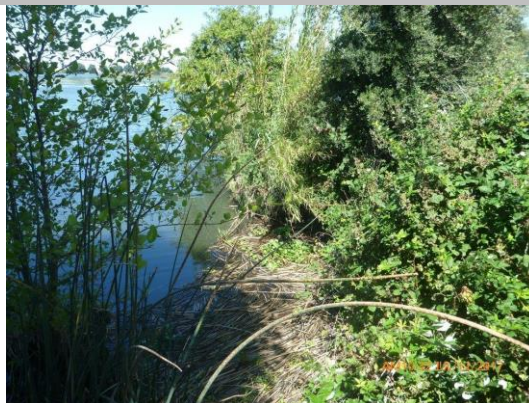
Photo 3 of 6 : SP_2019_RD2060_241_5_20190311_00003.jpg

LM Start	0.40	Rating **	M	Issue No.	5 (cont)	
LM End	0.40	Issue Type +	Ma	Location *	WS	
Category	Supplemental			GPS Latitude/Longitude		
				Start		End
Item	2017 Storm Damage			38.247894 °		38.247911 °
				-121.703492 °		-121.703539 °
DWR ID	DWR_RD2060_01_f _ 2017_5					
Comment Code						
Inspector Comment						
Levee Evaluation Comments						
Description:Erosion commences approximately 3/4 of the way down the slope, near the water line towards the waterside toe.						
Site ID No:358						
Site Designation:LMA-185						
Repair Type: Erosion						
Rating:Area of Concern						
Field Date:7/12/2017						
Notes: Small erosion into bank.

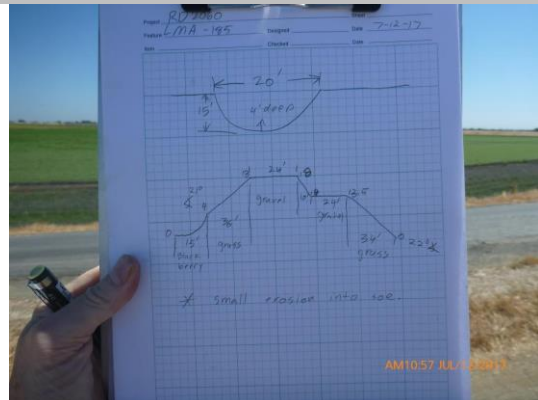
Photo 6 of 6 : SP_2019_RD2060_241_5_20190311_00006.jpg

LM Start	0.40	Rating **	M	Issue No.	5 (cont)	
LM End	0.40	Issue Type +	Ma	Location *	WS	
Category	Supplemental			GPS Latitude/Longitude		
				Start	End	
Item	2017 Storm Damage			38.247894 °	38.247911 °	
				-121.703492 °	-121.703539 °	
DWR ID	DWR_RD2060_01_f_2017_5					
Comment Code						
Inspector Comment						
Levee Evaluation Comments						
Description:Erosion commences approximately 3/4 of the way down the slope, near the water line towards the waterside toe.						
Site ID No:358						
Site Designation:LMA-185						
Repair Type: Erosion						
Rating:Area of Concern						
Field Date:7/12/2017						
Notes: Small erosion into bank.

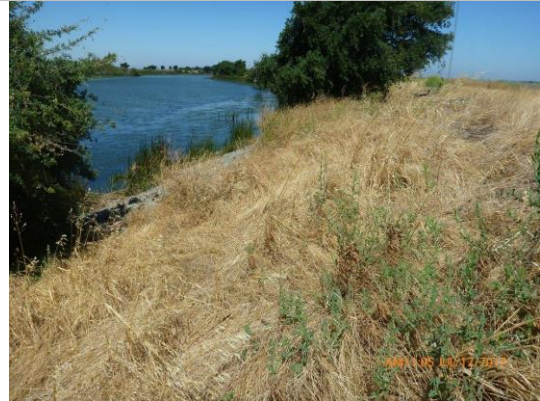
Photo 3 of 3 : SP_2019_RD2060_241_8_20190311_00009.jpg

LM Start	0.41	Rating **	M	Issue No.	8 (cont)	
LM End	0.42	Issue Type +	Ma	Location *	WS	
Category	Supplemental			GPS Latitude/Longitude		
				Start	End	
Item	2017 Storm Damage			38.248036 °	38.248017 °	
				-121.703539 °	-121.703789 °	
DWR ID	DWR_RD2060_01_f _ 2017_8					
Comment Code						
Inspector Comment						
<p>Levee Evaluation Comments</p> <p>Description:Erosion commences approximately halfway down the water side slope extending in to existing rip rap. Existing rip rap appears to have been pulled off in this section.</p> <p>Site ID No:359</p> <p>Site Designation:LMA-186</p> <p>Repair Type: Erosion</p> <p>Rating:Area of Concern</p> <p>Field Date:7/12/2017</p> <p>Notes: Site had riprap but is eroded away. Minor erosion in toe of levee.</p>

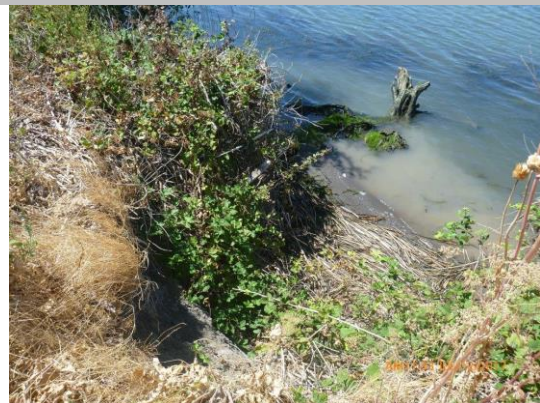
Photo 1 of 3 : SP_2019_RD2060_241_9_20190311_00010.jpg

LM Start	0.75	Rating **	M	Issue No.	9
LM End	0.76	Issue Type +	Ma	Location *	WS
Category	Supplemental			GPS Latitude/Longitude	
				Start	End
Item	2017 Storm Damage			38.249314 °	38.249400 °
				-121.709461 °	-121.709608 °
DWR ID	DWR_RD2060_01_f_ 2017_9				
Comment Code					
Inspector Comment					
Levee Evaluation Comments					
Description: Erosion commences approximately halfway down the water side slope extending in to existing rip rap. Erosion is concentrated near the waterline. Existing rip rap appears to have been pulled off in this section.					
Site ID No: 360					
Site Designation: LMA-187					
Repair Type: Erosion					
Rating: Area of Concern					
Field Date: 7/12/2017					
Notes: Erosion looks old but has progressed this year.

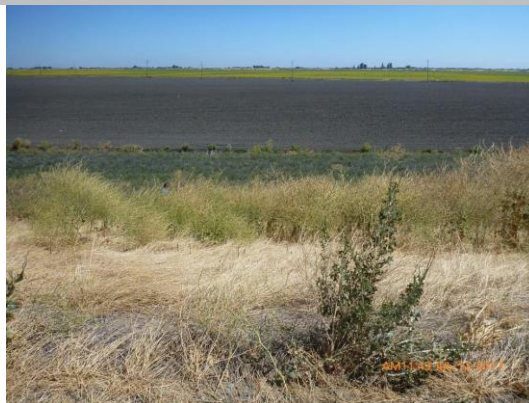
Photo 2 of 3 : SP_2019_RD2060_241_9_20190311_00011.jpg

LM Start	0.75	Rating **	M	Issue No.	9 (cont)
LM End	0.76	Issue Type +	Ma	Location *	WS
Category	Supplemental		GPS Latitude/Longitude		
			Start	End	
Item	2017 Storm Damage		38.249314 °	38.249400 °	
			-121.709461 °	-121.709608 °	
DWR ID	DWR_RD2060_01_f_2017_9				
Comment Code					
Inspector Comment					
<p>Levee Evaluation Comments</p> <p>Description: Erosion commences approximately halfway down the water side slope extending in to existing rip rap. Erosion is concentrated near the waterline. Existing rip rap appears to have been pulled off in this section.</p> <p>Site ID No: 360</p> <p>Site Designation: LMA-187</p> <p>Repair Type: Erosion</p> <p>Rating: Area of Concern</p> <p>Field Date: 7/12/2017</p> <p>Notes: Erosion looks old but has progressed this year.</p>

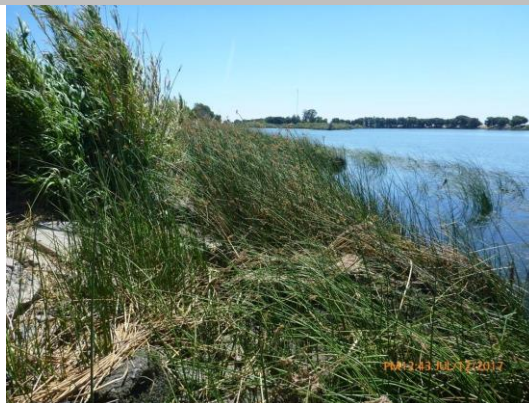
Photo 1 of 4 : SP_2019_RD2060_241_10_20190311_00013.jpg

LM Start	0.92	Rating **	M	Issue No.	10
LM End	0.93	Issue Type +	Ma	Location *	WS
Category	Supplemental			GPS Latitude/Longitude	
				Start	End
Item	2017 Storm Damage			38.250875 °	38.250953 °
				-121.711942 °	-121.712078 °
DWR ID	DWR_RD2060_01_f_2018_10				
Comment Code					
Inspector Comment					
Levee Evaluation Comments					
Description:Sloughing commences approximately halfway down the water side slope.					
Site ID No:361					
Site Designation:LMA-188					
Repair Type: Erosion					
Rating:Area of Concern					
Field Date:7/12/2017					
Notes: Minor sloughing, mostly riprap has moved down the slope and into channel.

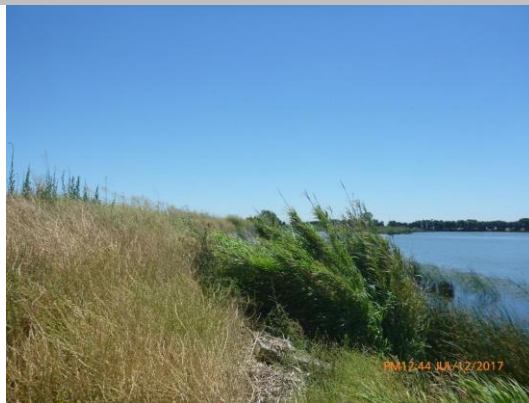
Photo 3 of 4 : SP_2019_RD2060_241_10_20190311_00015.jpg

LM Start	0.92	Rating **	M	Issue No.	10 (cont)
LM End	0.93	Issue Type +	Ma	Location *	WS
Category	Supplemental			GPS Latitude/Longitude	
				Start	End
Item	2017 Storm Damage			38.250875 °	38.250953 °
				-121.711942 °	-121.712078 °
DWR ID	DWR_RD2060_01_f_2018_10				
Comment Code					
Inspector Comment					
Levee Evaluation Comments					
Description:Sloughing commences approximately halfway down the water side slope.					
Site ID No:361					
Site Designation:LMA-188					
Repair Type: Erosion					
Rating:Area of Concern					
Field Date:7/12/2017					
Notes: Minor sloughing, mostly riprap has moved down the slope and into channel.

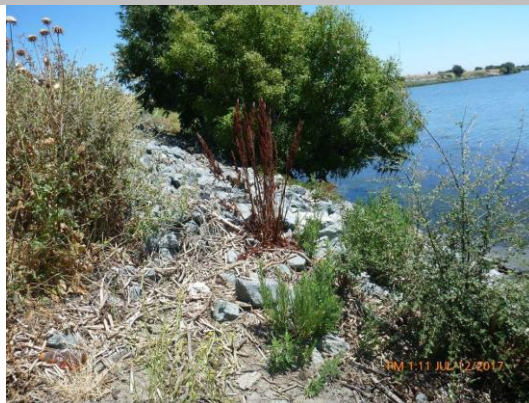
Photo 1 of 3 : SP_2019_RD2060_241_15_20190311_00017.jpg

LM Start	1.04	Rating **	M	Issue No.	15
LM End	1.08	Issue Type +	Ma	Location *	WS
Category	Supplemental			GPS Latitude/Longitude	
				Start	End
Item	2017 Storm Damage			38.251058 °	38.250872 °
				-121.714050 °	-121.714792 °
DWR ID	DWR_RD2060_01_f_2017_15				
Comment Code					
Inspector Comment					
Levee Evaluation Comments Description:Erosion commences approximately 3/4 of the way down the water side slope concentrated at the waterline. Site ID No:362 Site Designation:LMA-189 Repair Type: Erosion Rating:Area of Concern Field Date:7/12/2017 Notes: Erosion due to lack of revetment. Erosion ends at riprap downstream. Vertical cut at summer wse.

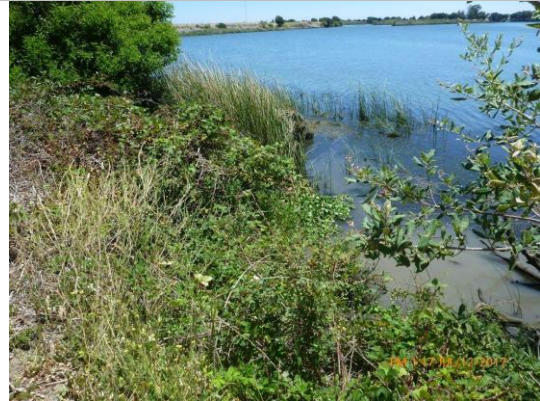
Photo 3 of 3 : SP_2019_RD2060_241_15_20190311_00019.jpg

LM Start	1.04	Rating **	M	Issue No.	15 (cont)
LM End	1.08	Issue Type +	Ma	Location *	WS
Category	Supplemental			GPS Latitude/Longitude	
				Start	End
Item	2017 Storm Damage			38.251058 °	38.250872 °
				-121.714050 °	-121.714792 °
DWR ID	DWR_RD2060_01_f_2017_15				
Comment Code					
Inspector Comment					
Levee Evaluation Comments					
Description:Erosion commences approximately 3/4 of the way down the water side slope concentrated at the waterline.					
Site ID No:362					
Site Designation:LMA-189					
Repair Type: Erosion					
Rating:Area of Concern					
Field Date:7/12/2017					
Notes: Erosion due to lack of revetment. Erosion ends at riprap downstream. Vertical cut at summer wse.

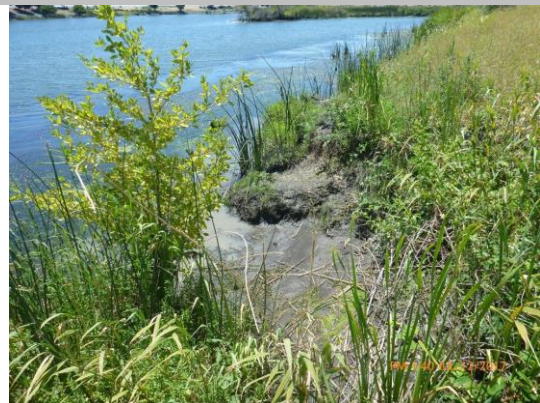
Photo 1 of 3 : SP_2019_RD2060_241_16_20190311_00020.jpg

LM Start	1.09	Rating **	M	Issue No.	16
LM End	1.10	Issue Type +	Ma	Location *	WS
Category	Supplemental			GPS Latitude/Longitude	
				Start	End
Item	2017 Storm Damage			38.250844 °	38.250833 °
				-121.714944 °	-121.714994 °
DWR ID	DWR_RD2060_01_f_2017_16				
Comment Code					
Inspector Comment					
Levee Evaluation Comments					
Description:Erosion commences approximately halfway down the water side slope extending to the toe.					
Site ID No:363					
Site Designation:LMA-190					
Repair Type: Erosion					
Rating:Area of Concern					
Field Date:7/12/2017					
Notes: Small erosion up to high water line. Cuts into slope with 6' vertical cut.

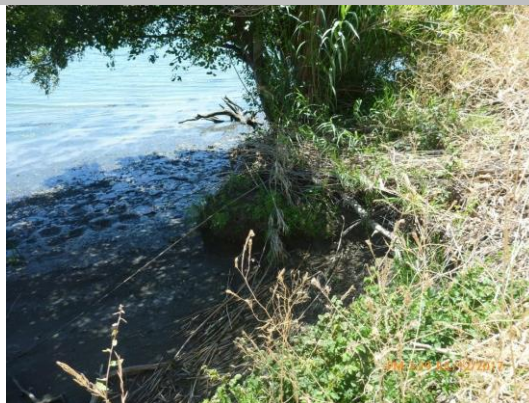
Photo 1 of 3 : SP_2019_RD2060_241_20_20190311_00023.jpg

LM Start	1.39	Rating **	A/W	Issue No.	20
LM End	1.56	Issue Type +	Ma	Location *	WS
Category	Supplemental			GPS Latitude/Longitude	
				Start	End
Item	2017 Storm Damage			38.251886 °	38.252619 °
				-121.719933 °	-121.722842 °
DWR ID	DWR_RD2060_01_f_2017_20				
Comment Code					
Inspector Comment					
Levee Evaluation Comments					
Description:Erosion commences approximately halfway down the water side slope extending to the toe.					
Site ID No:365					
Site Designation:LMA-192					
Repair Type: Erosion					
Rating:Serious					
Field Date:7/12/2017					
Notes: Several deep narrow cuts into levee, but mostly minor erosion at highwater line.

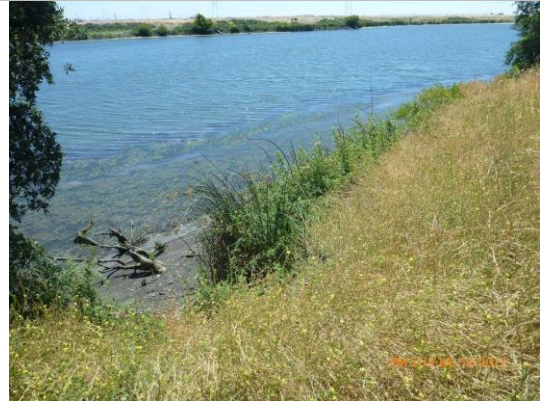
Photo 3 of 3 : SP_2019_RD2060_241_20_20190311_00025.jpg

LM Start	1.39	Rating **	A/W	Issue No.	20 (cont)
LM End	1.56	Issue Type +	Ma	Location *	WS
Category	Supplemental			GPS Latitude/Longitude	
				Start	End
Item	2017 Storm Damage			38.251886 °	38.252619 °
				-121.719933 °	-121.722842 °
DWR ID	DWR_RD2060_01_f_2017_20				
Comment Code					
Inspector Comment					
Levee Evaluation Comments					
Description:Erosion commences approximately halfway down the water side slope extending to the toe.					
Site ID No:365					
Site Designation:LMA-192					
Repair Type: Erosion					
Rating:Serious					
Field Date:7/12/2017					
Notes: Several deep narrow cuts into levee, but mostly minor erosion at highwater line.

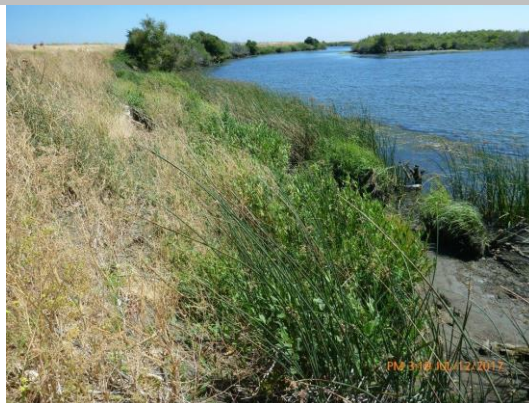
Photo 1 of 3 : SP_2019_RD2060_241_21_20190311_00026.jpg

LM Start	1.81	Rating **	A/W	Issue No.	21
LM End	1.84	Issue Type +	Ma	Location *	WS
Category	Supplemental			GPS Latitude/Longitude	
				Start	End
Item	2017 Storm Damage			38.255972 °	38.256247 °
				-121.724197 °	-121.724464 °
DWR ID	DWR_RD2060_01_f_2017_21				
Comment Code					
Inspector Comment					
Levee Evaluation Comments					
Description:Erosion commences approximately halfway down the water side slope extending to the toe. Some slipping into the toe has occurred due to deep erosion.					
Site ID No:366					
Site Designation:LMA-193					
Repair Type: Erosion					
Rating:Serious					
Field Date:7/12/2017					
Notes: Erosion extends halfway into the slope.

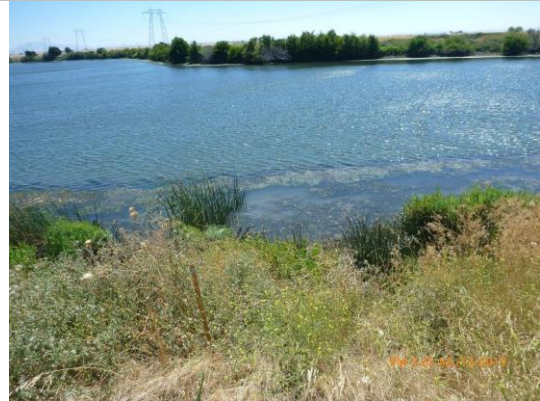
Photo 3 of 3 : SP_2019_RD2060_241_21_20190311_00028.jpg

LM Start	1.81	Rating **	A/W	Issue No.	21 (cont)
LM End	1.84	Issue Type +	Ma	Location *	WS
Category	Supplemental			GPS Latitude/Longitude	
Item				Start	End
	2017 Storm Damage			38.255972 °	38.256247 °
				-121.724197 °	-121.724464 °
DWR ID	DWR_RD2060_01_f_2017_21				
Comment Code					
Inspector Comment					
Levee Evaluation Comments					
Description:Erosion commences approximately halfway down the water side slope extending to the toe. Some slipping into the toe has occurred due to deep erosion.					
Site ID No:366					
Site Designation:LMA-193					
Repair Type: Erosion					
Rating:Serious					
Field Date:7/12/2017					
Notes: Erosion extends halfway into the slope.

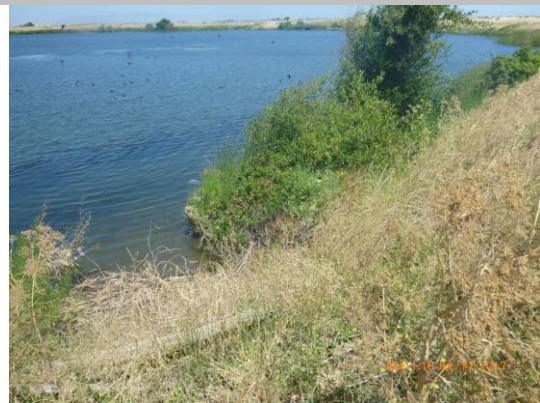
Photo 1 of 3 : SP_2019_RD2060_241_22_20190311_00029.jpg

LM Start	1.90	Rating **	M	Issue No.	22
LM End	1.95	Issue Type +	Ma	Location *	WS
Category	Supplemental			GPS Latitude/Longitude	
				Start	End
Item	2017 Storm Damage			38.257208 °	38.257842 °
				-121.724619 °	-121.724694 °
DWR ID	DWR_RD2060_01_f_2017_22				
Comment Code					
Inspector Comment					
Levee Evaluation Comments					
Description:Erosion commences approximately halfway down the water side slope extending to the toe. Some slipping into the toe has occurred.					
Site ID No:367					
Site Designation:LMA-194					
Repair Type: Erosion					
Rating:Area of Concern					
Field Date:7/12/2017					
Notes: Minor crackingobserved below the hinge point and minor erosion at levee toe.

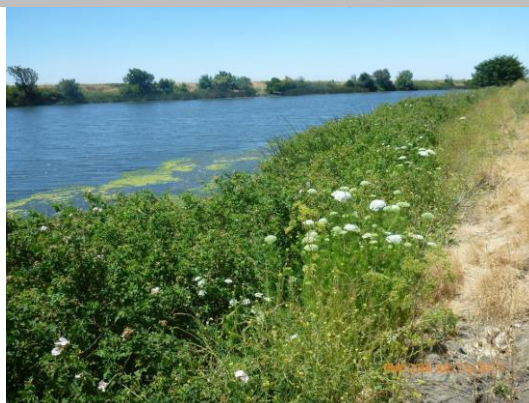
Photo 1 of 3 : SP_2019_RD2060_241_26_20190311_00041.jpg

LM Start	3.17	Rating **	M	Issue No.	26
LM End	3.17	Issue Type +	Ma	Location *	
Category	Supplemental			GPS Latitude/Longitude	
				Start	End
Item	2017 Storm Damage			38.259925 °	38.259903 °
				-121.742236 °	-121.742281 °
DWR ID	DWR_RD2060_01_f_2017_26				
Comment Code					
Inspector Comment					
Levee Evaluation Comments Description: Erosion occurs near the waterline. Site ID No: 371 Site Designation: LMA-198 Repair Type: Erosion Rating: Area of Concern Field Date: 7/13/2017 Notes: Minor erosion with sloughing. Horizontal cracks 3.5' deep.

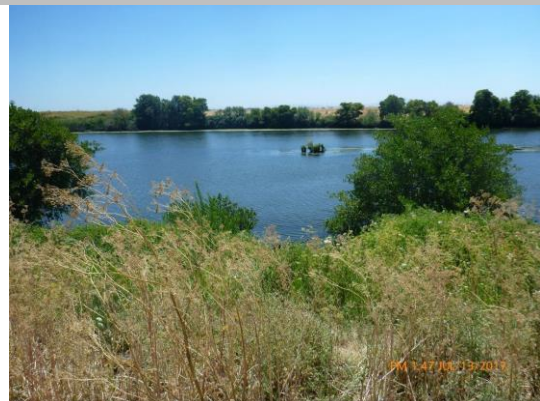
LM Start	3.67	Rating **	M	Issue No.	28
LM End	3.67	Issue Type +	Ma	Location *	
Category	Supplemental			GPS Latitude/Longitude	
				Start	End
Item	2017 Storm Damage			38.261181 °	38.261167 °
				-121.749542 °	-121.749592 °
DWR ID	DWR_RD2060_01_f_2017_28				
Comment Code					
Inspector Comment					
Levee Evaluation Comments					
Description:Erosion is concentrated near the water line.					
Site ID No:374					
Site Designation:LMA-201					
Repair Type: Erosion					
Rating:Area of Concern					
Field Date:7/13/2017					
Notes: Small narrow and deep cut. May have been caused by a collapsed beaver den.

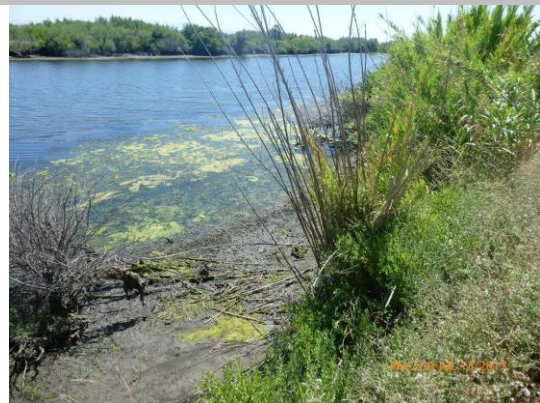
LM Start	4.40	Rating **	M	Issue No.	30
LM End	4.46	Issue Type +	Ma	Location *	
Category	Supplemental			GPS Latitude/Longitude	
				Start	End
Item	2017 Storm Damage			38.260850 °	38.260425 °
				-121.761875 °	-121.762861 °
DWR ID	DWR_RD2060_01_f_2017_30				
Comment Code					
Inspector Comment					
Levee Evaluation Comments					
Description:Erosion/sloughing commences approximately halfway down the slope. Erosion is concentrated mostly near the water line and has resulting in slippage of the slope.					
Site ID No:377					
Site Designation:LMA-204					
Repair Type: Erosion					
Rating:Area of Concern					
Field Date:7/13/2017					
Notes: large cut is 100' of 320' site. Large cut is 12' vertical and the rest is 6'.

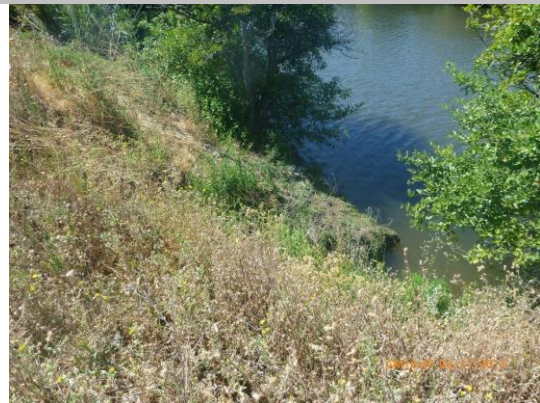
LM Start	5.00	Rating **	M	Issue No.	34
LM End	5.01	Issue Type +	Ma	Location *	
Category	Supplemental			GPS Latitude/Longitude	
				Start	End
Item	2017 Storm Damage			38.262636 °	38.262658 °
				-121.770503 °	-121.770547 °
DWR ID	DWR_RD2060_01_f_2017_34				
Comment Code					
Inspector Comment					
Levee Evaluation Comments					
Description:Erosion is concentrated mostly near the water line and has resulting in slippage of the slope into the toe.					
Site ID No:381					
Site Designation:LMA-208					
Repair Type: Erosion					
Rating:Area of Concern					
Field Date:7/17/2017					
Notes: Extended site from 15' to 75' to include LMA-209. Small erosions will become 1 site next high water due to sloughing between them.

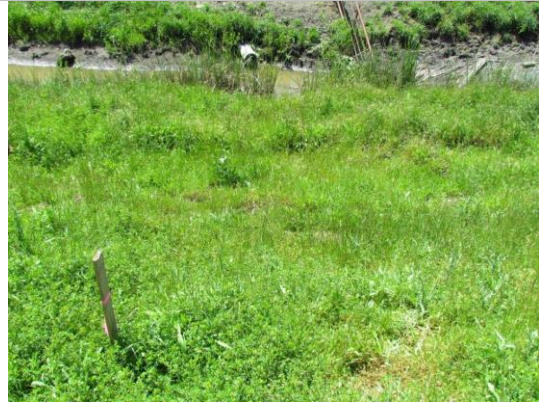
Looking down from the shoulder at the sloughing in the slope towards the irrigation ditch at toe.

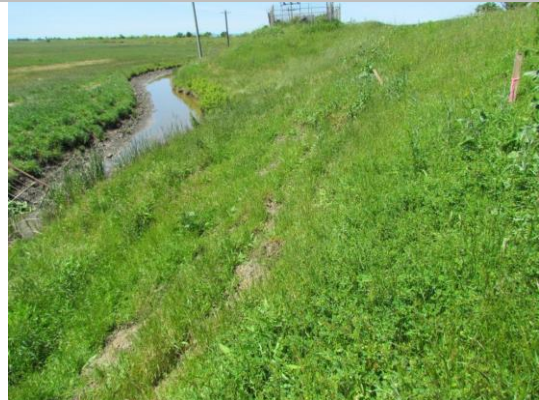
Standing on the slope looking upstream at the slough.

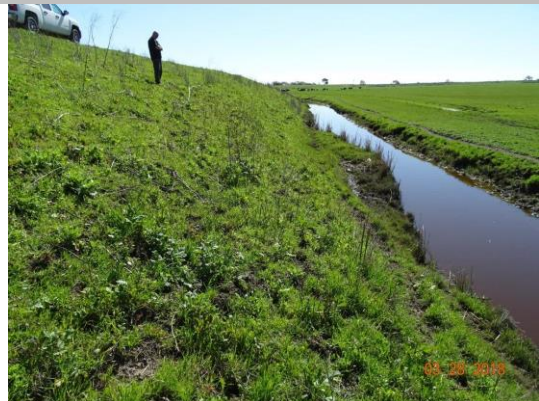
Lower landside slope has slumped into ditch. Should be repaired.

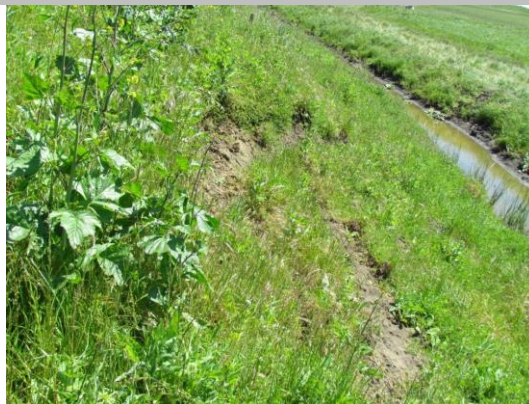
LM Start	0.15	Rating **	A/W	Issue No.	19
LM End	0.19	Issue Type +	Ma	Location *	LS
Category	Earthen Levee			GPS Latitude/Longitude	
				Start	End
Item	Slope Stability			38.295738 °	38.295559 °
				-121.746293 °	-121.745583 °
DWR ID	DWR_RD2060_03_s_2017_19				
Comment Code					
S1 : Repair slope instability.					
Inspector Comment					
There are several signs of sloughing occuring on the slope.

Standing at levee mile 0.15 looking downstream from the landside slope.

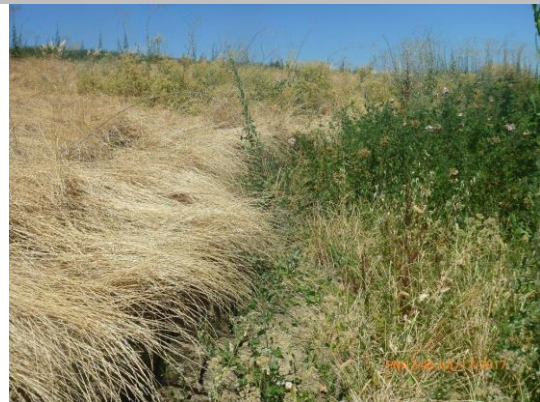
LM Start	3.96	Rating **	A/W	Issue No.	41
LM End	4.00	Issue Type +	Ma	Location *	
Category	Supplemental			GPS Latitude/Longitude	
				Start	End
Item	2017 Storm Damage			38.262114 °	38.261583 °
				-121.697978 °	-121.697647 °
DWR ID	DWR_RD2060_03_f_2017_41				
Comment Code					
Inspector Comment					
Levee Evaluation Comments					
Description:Erosion commences approximately halfway down the slope and results in sloughing into the waterside toe.					
Site ID No:411					
Site Designation:LMA-238					
Repair Type: Erosion					
Rating:Serious					
Field Date:7/18/2017					
Notes: This site includes LMA-235. Wide erosion looks like several small sited merged. Heavy veg indicates slow erosion.

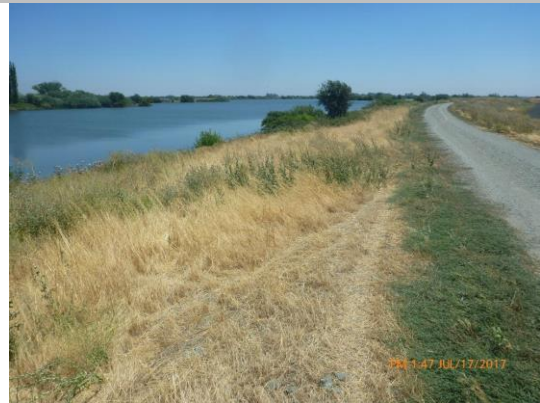
LM Start	4.06	Rating **	A/W	Issue No.	43
LM End	4.08	Issue Type +	Ma	Location *	
Category	Supplemental			GPS Latitude/Longitude	
				Start	End
Item	2017 Storm Damage			38.260789 °	38.260644 °
				-121.696964 °	-121.696828 °
DWR ID	DWR_RD2060_03_f_2017_43				
Comment Code					
Inspector Comment					
Levee Evaluation Comments					
Description:Erosion commences approximately halfway down the slope and results in sloughing into the waterside toe.					
Site ID No:409					
Site Designation:LMA-236					
Repair Type: Erosion					
Rating:Area of Concern					
Field Date:7/18/2017					
Notes: 3' cut to slope down to water, with a 50' deep cut. Heavy veg suggests slow progression of erosion.
